Contract #: 04-0120F4Cty: SF/ALA Rte: 80 PM: 13.2/13.9File #: 1.28**WELDING INSPECTION REPORT****Resident Engineer:**Siegenthaler, Peter**Address:** 333 Burma Road**City:** Oakland, CA 94607**Report No:** WIR-022204**Date Inspected:** 29-Mar-2011**Project Name:** SAS Superstructure**OSM Arrival Time:** 700**Prime Contractor:** American Bridge/Fluor Enterprises, a JV**OSM Departure Time:** 1530**Contractor:** American Bridge/Fluor Enterprises, a JV**Location:** Job Site

Caltrans Office of Structural Material (OSM) Quality Assurance Inspector (QAI) Joselito Lizardo was present at the Self Anchored Suspension (SAS) job site as requested to perform observations on the welding of components for the San Francisco Oakland Bay Bridge (SFOBB) Project.

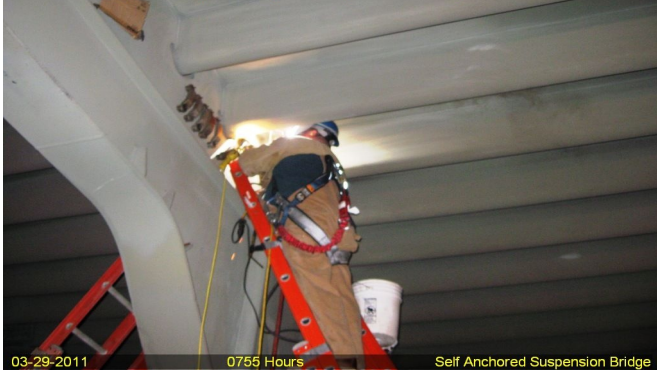
At OBG 7E-PP53-E4-#2 & 4 lifting lug access holes to top deck plate inside - ABF welder Jason Collins was observed 4G SMAW back welding cover pass on the infill plate to top deck plate butt joint. The welder was noted using 1/8" diameter E7018H4R electrode implementing Caltrans approved Welding Procedure Specification (WPS) ABF-WPS-D15-1110A. During welding, ABF QC Fred Von Hoff was noted monitoring the welder's welding parameters. During the shift, cover pass welding on the two access holes was completed and the welder also ground flush the weld cover reinforcement as required. After the completion of the flush grinding, the welder has moved to the top deck (outside) and setup his welding equipment at new lifting lug access holes location at OBG 7E-PP55-E4-#1 to 4.

At OBG 7E-PP53-E4-#4 lifting lug access hole to top deck plate inside, ABF welder Jason Collins was observed performing 4G Shielded Metal Arc Welding (SMAW) welding cover pass on butt joint.

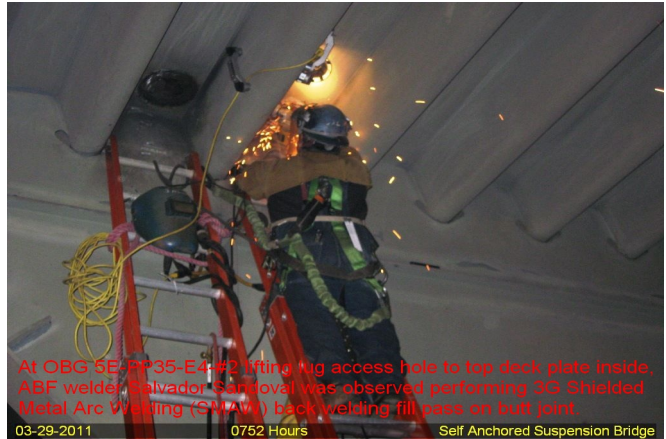
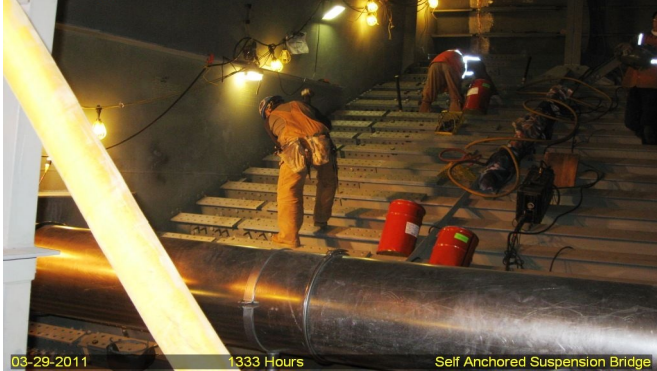
At OBG 9W/10W side plate 'C' inside, ABF bolting crew were noted removing the temporary WT stiffener connection plates to give access to the Bug-o track mounted welder nozzle holder.

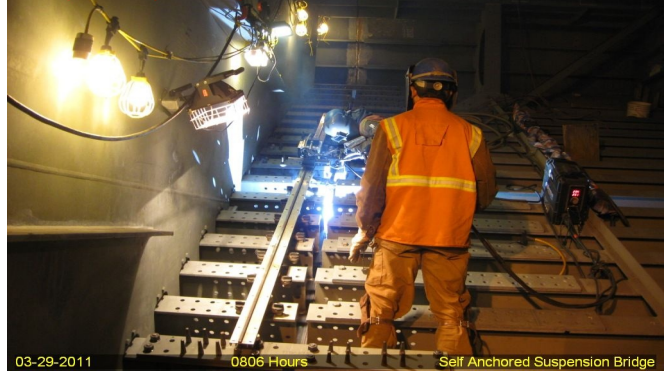
At OBG 9W/10W side plate 'C2' (0mm to 2640mm) inside, QA randomly observed ABF/JV qualified welder Sungtao, Huang ID # 3794 continuing to perform CJP groove (splice) welding cover pass on the splice butt joint. The welder was observed perform automatic welding in the 3G (vertical) position utilizing a dual shield Flux Cored Arc Welding (FCAW-G) with E71T-1M, 1/16" diameter wire electrode and implementing Caltrans approved Welding Procedure Specification (WPS) ABF-WPS-D15-3042B-1. The joint being welded has a single V-groove butt joint with backing bar. The splice joint was preheated and maintained to greater than 150 degrees Fahrenheit using Miller Proheat 35 Induction Heating System heater blankets located at the opposite side of the plate prior/during welding. During welding, ABF Quality Control (QC) Steve Jensen was noted monitoring the welding parameters of the welder. During the shift, cover pass welding was completed and the welder has moved to side plate 'C1' (2640mm to 5278mm) of the same OBG. The welder had waited also for sometime before they have moved to their new location due to the bolting crew was on their way removing the temporary WT stiffener connection plates.

At OBG 9W/10W side plate 'C' inside, ABF welder Songtao, Huang was observed performing 3G Flux Cored Arc Welding (FCAW-G) welding cover pass on splice butt joint.
